**Hydromodification Susceptibility
Documentation Report and
Mapping: Santa Ana Region**

January 18, 2017

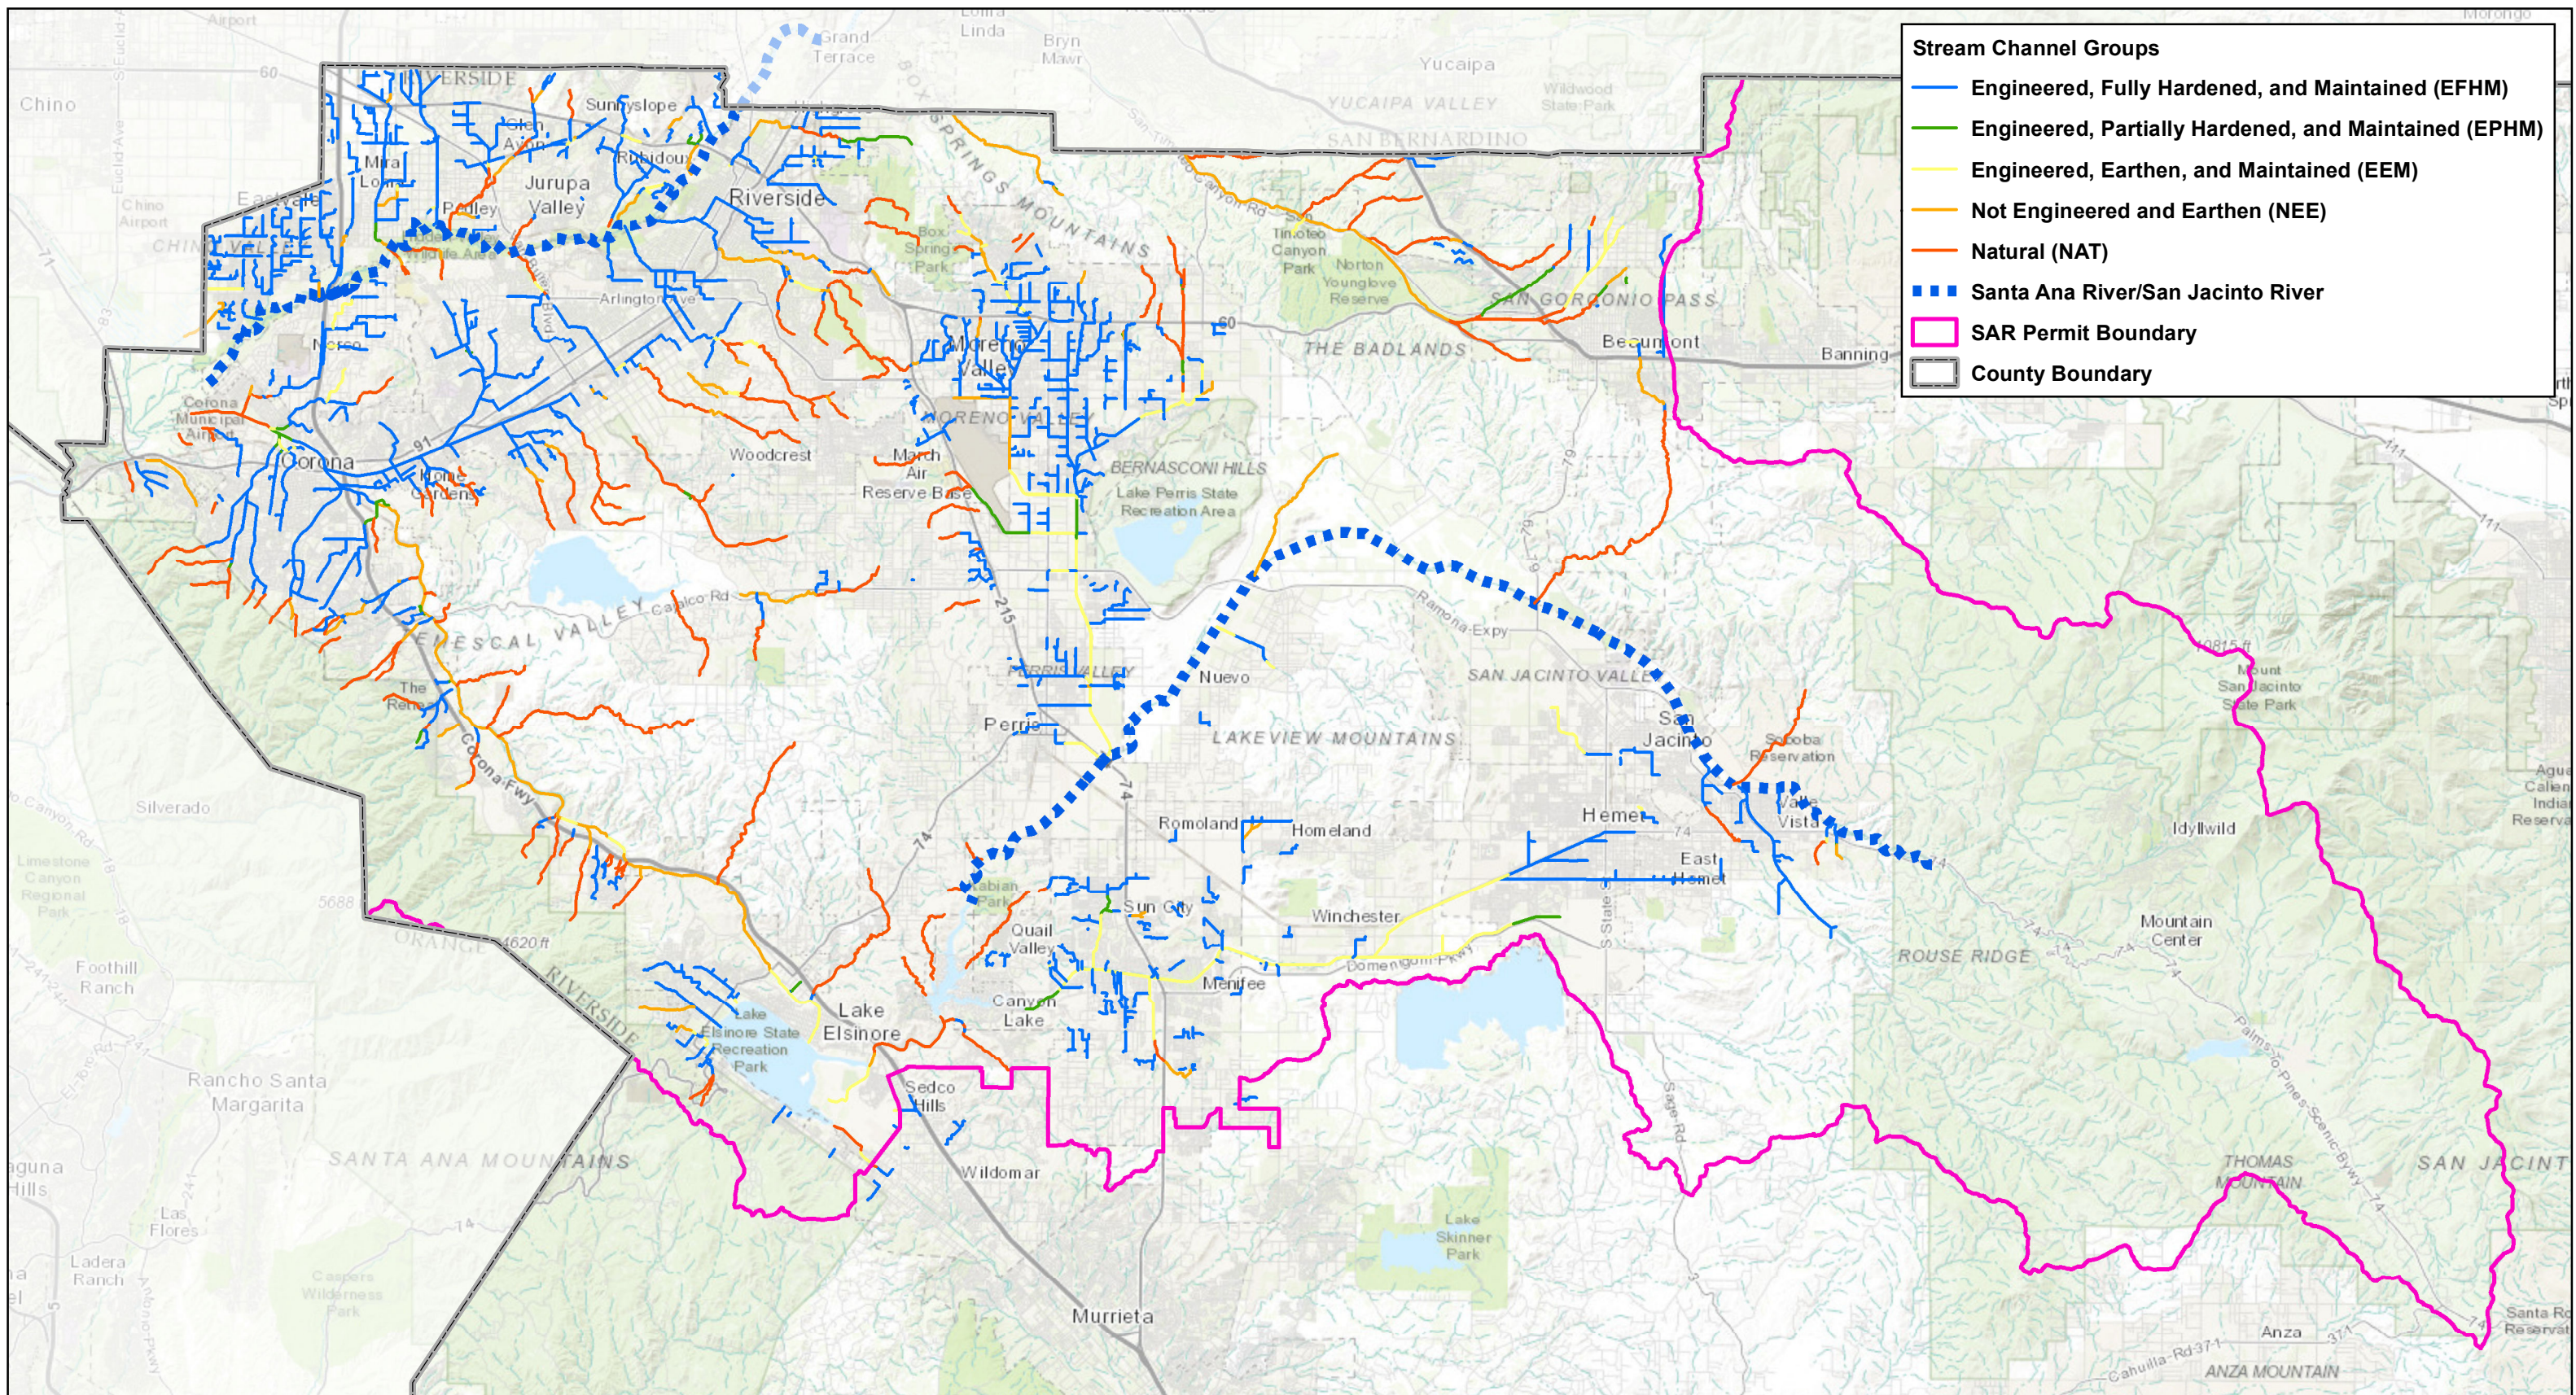
MAP 1

This section discusses how the existing stream channels were delineated. It also discusses the grouping system used for the stream channel segments and provides the Existing Stream Channel Delineation Map, see Map 1.

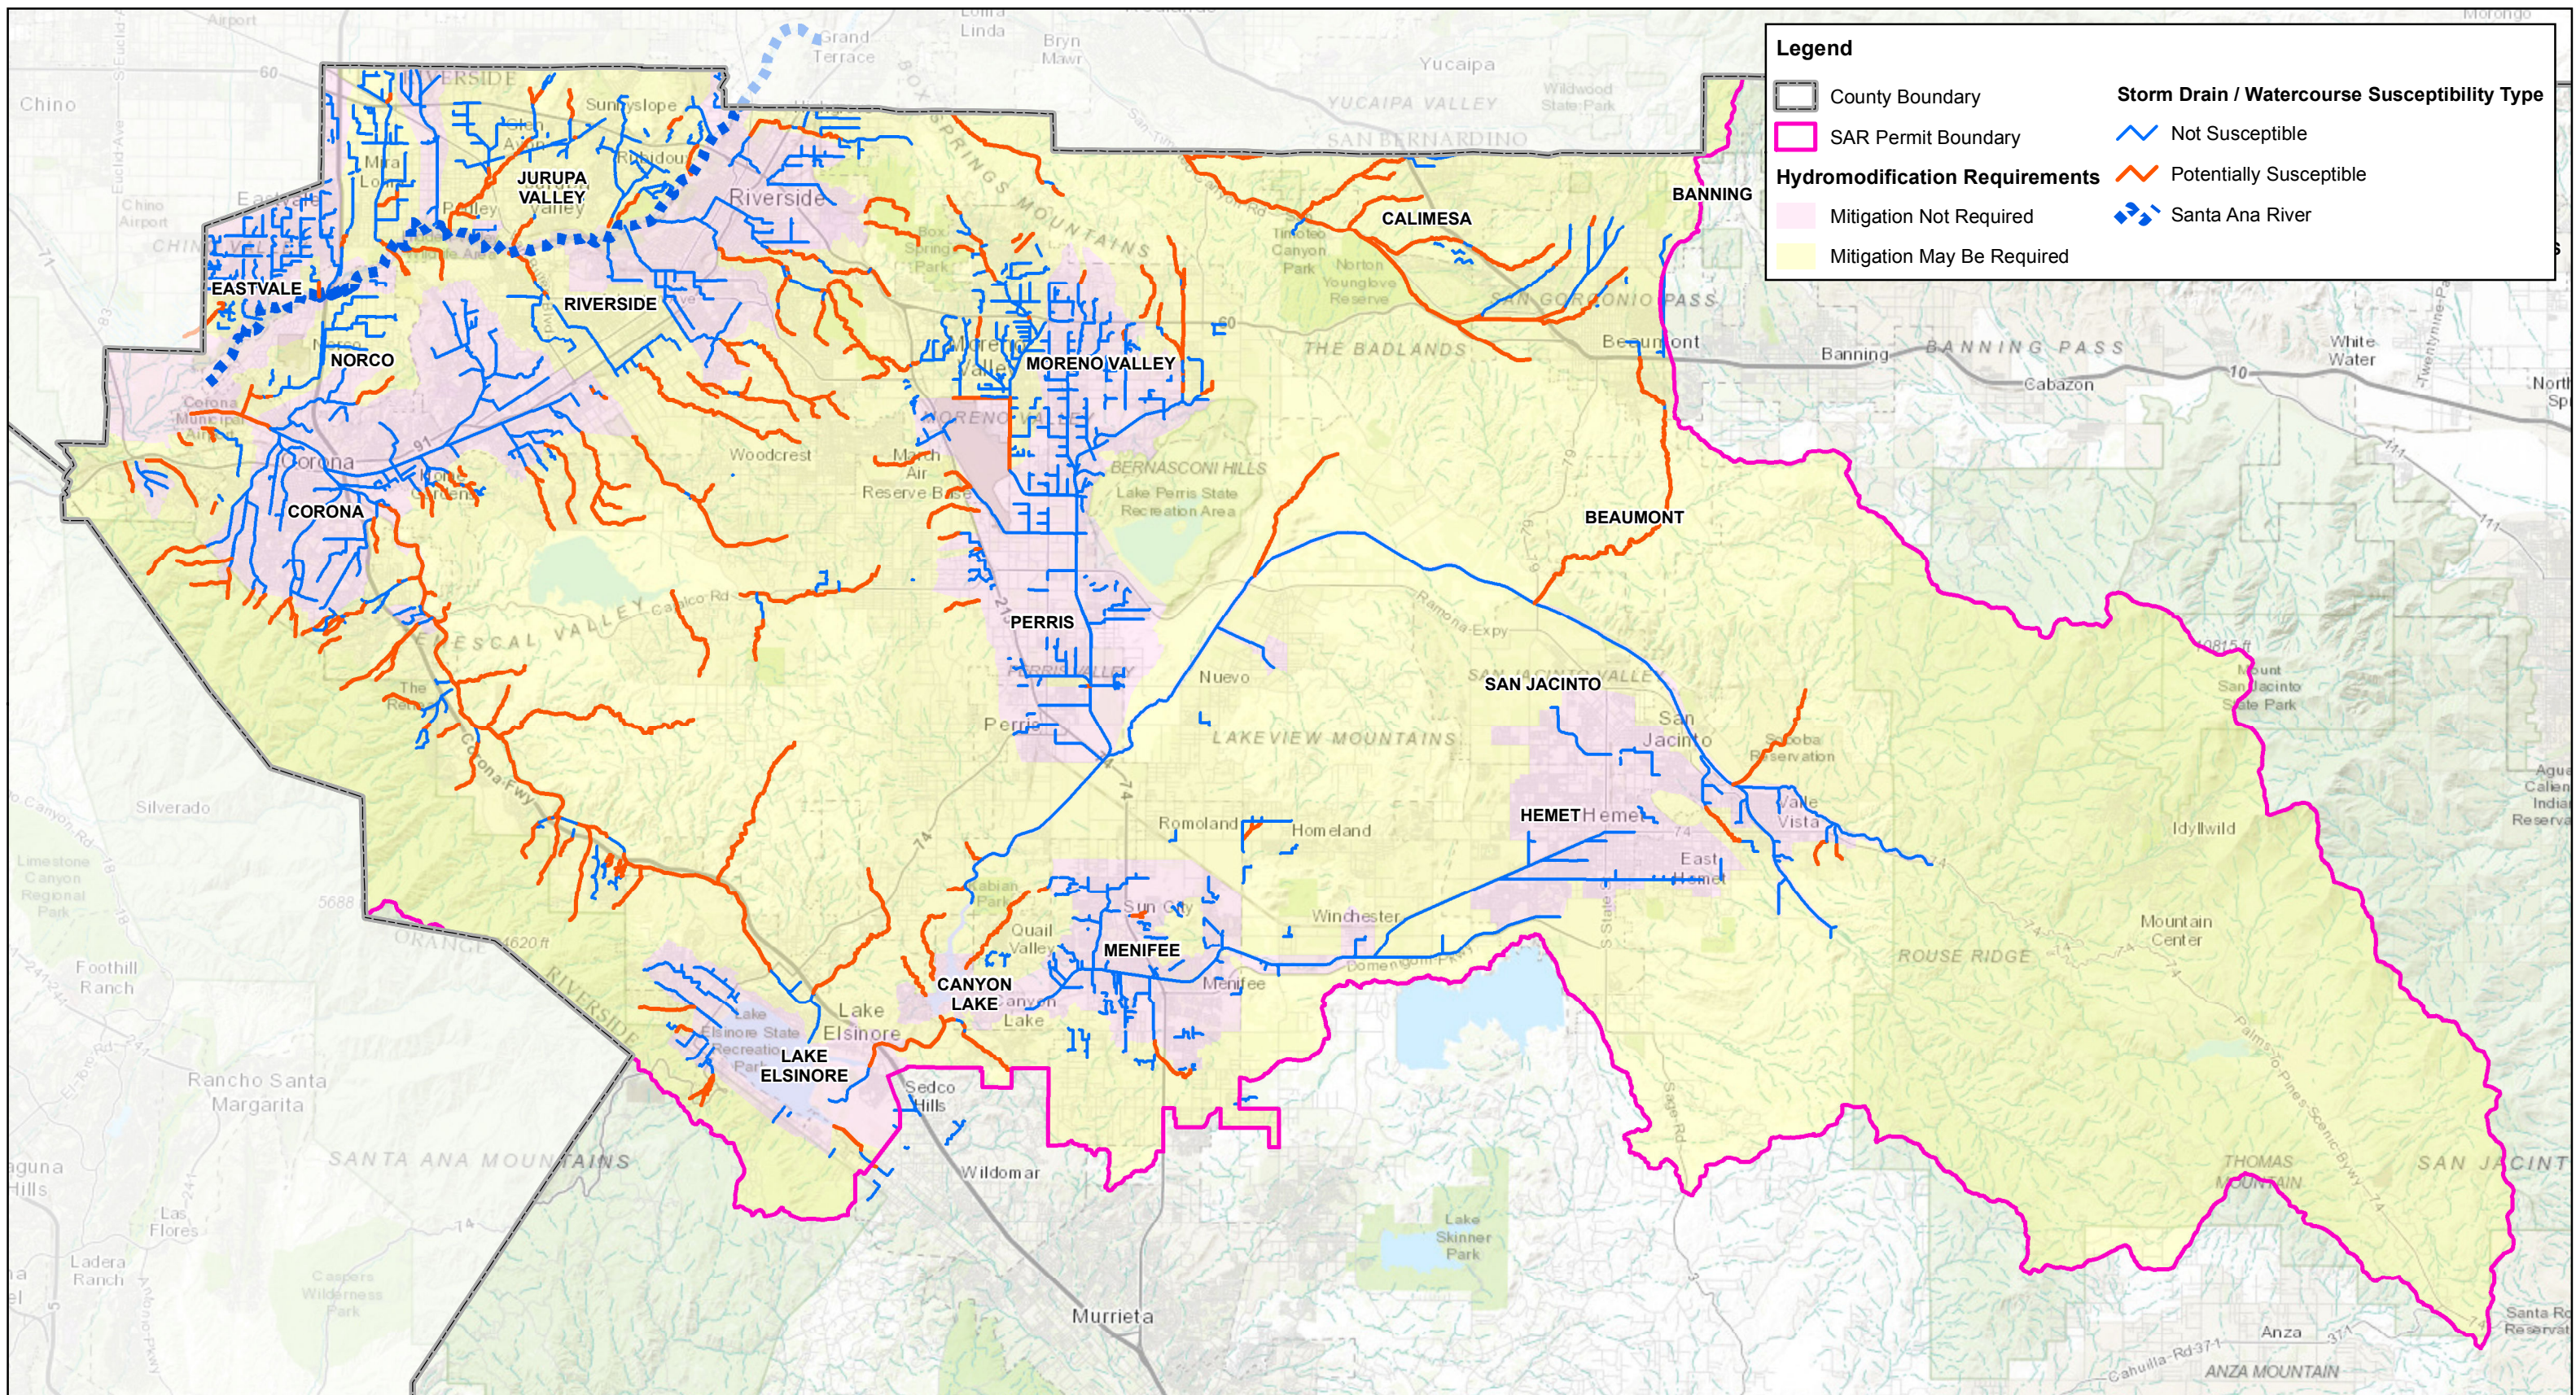
MAP 2

This section describes the HCOC applicability criteria and discusses the methodology for determining watershed areas where HCOC requirements may be applicable. The results of the HCOC Applicability Assessment are used to develop a comprehensive map of the MS4 Permit area which identifies those areas that are tributary to potentially susceptible stream channel segments and where runoff from New Development or Significant Redevelopment may cause a HCOC. The HCOC Applicability Map (see Map 2) provides a delineation of the potentially susceptible stream channel segments and the watershed areas that are applicable to the HCOC requirements.

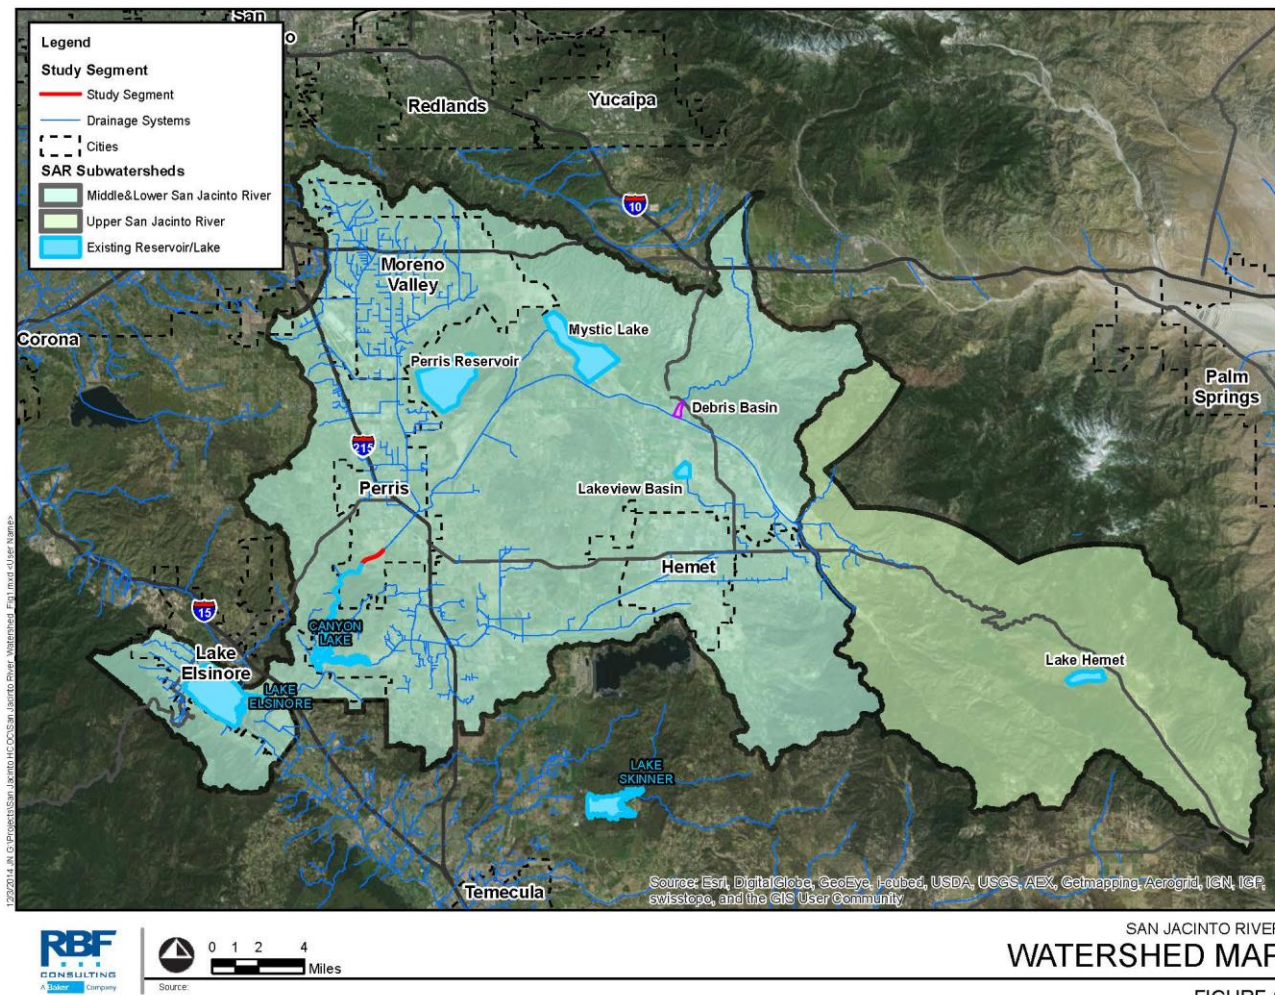
Figure 1 - Watershed Map

Figure 1 shows the location of the 3.8 mile study reach and watershed boundaries.

At the request of the Santa Ana Regional Water Quality Control Board (Santa Ana Regional Board), a stream stability study for the 3.8-mile segment of the San Jacinto River upstream of Canyon Lake was performed (Figure 1) to show that the San Jacinto River is not an HCOC. The reach is representative of the conditions observed along the San Jacinto River, downstream of the confluence with Bautista Creek. The analysis demonstrates that both drainage and stream characteristics provide a basis to exempt the San Jacinto River from the HCOC mitigation requirements.

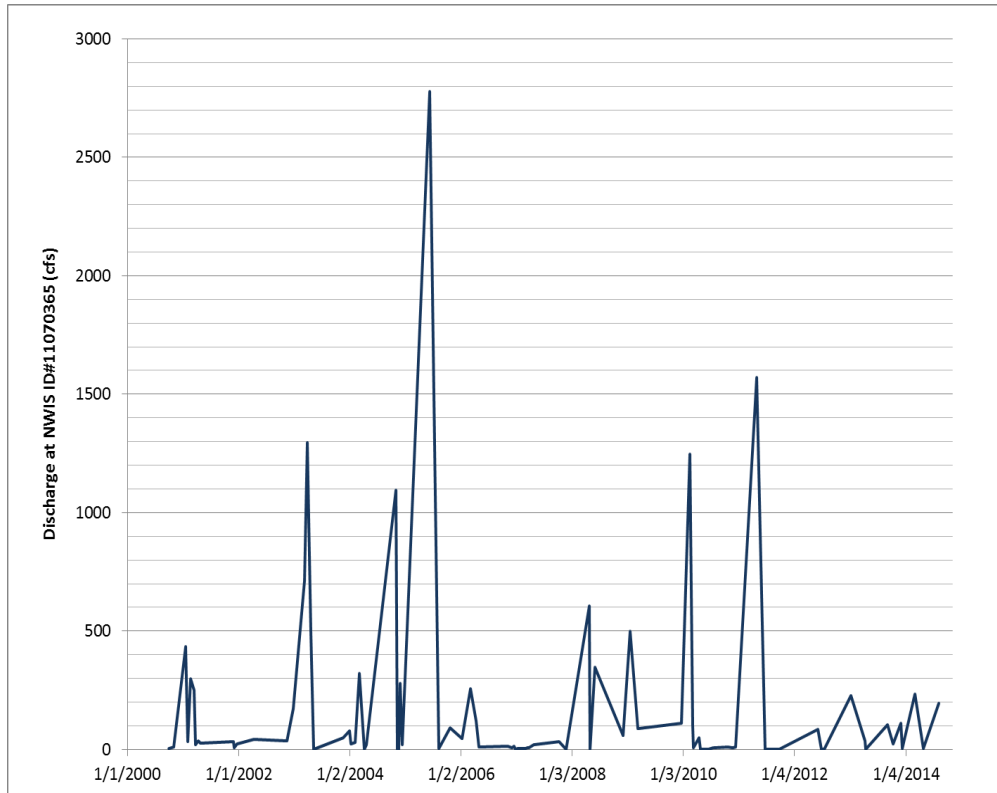
Figure 2 - USGS Gage #11070365

An evaluation of USGS Streamgage 11070365, located 2,900 feet downstream of Goetz Road on the San Jacinto River, was performed to characterize the actual peak discharges resulting from the engineered levees in the San Jacinto River adjacent to Mystic Lake, the backwater effects caused by the Ramona Expressway bridge and culvert, while not hypothetically assuming that Mystic Lake is full. Limited available data at USGS Streamgage 11070365 extends from October 01, 2000 to November 07, 2014. The maximum discharge observed at the streamgage was approximately 2,780 cfs in December 2005.

The selection of the 2-year discharge and 10-year discharge is supported by the current state of the science on hydromodification in Southern California. The 2-year discharge has been identified as the dominant discharge by Leopold (1964), i.e. which performs the most work cumulatively on the channel that may result in channel degradation and serves as the basis to the SAR HMP. Additional studies have identified the range of geomorphically-significant flows, i.e. the range of flows that perform 95-percent of the cumulative work on the channel (10-percent of the 2-year discharge to the 10 year discharge). Conservatively, hydraulic computations and the rapid stream assessment of this stream stability study are based on the upper boundary of the range of geomorphically-significant flows, i.e. the 10-year discharge. The construction of Lake Hemet, the operation of historical levees to the San Jacinto River adjacent to Mystic Lake, and the backwater effects caused by the Ramona Expressway bridge all play a major part in attenuating flows into the lower reach of San Jacinto River as seen on the flow records at the streamgage(s) of Figure 2.

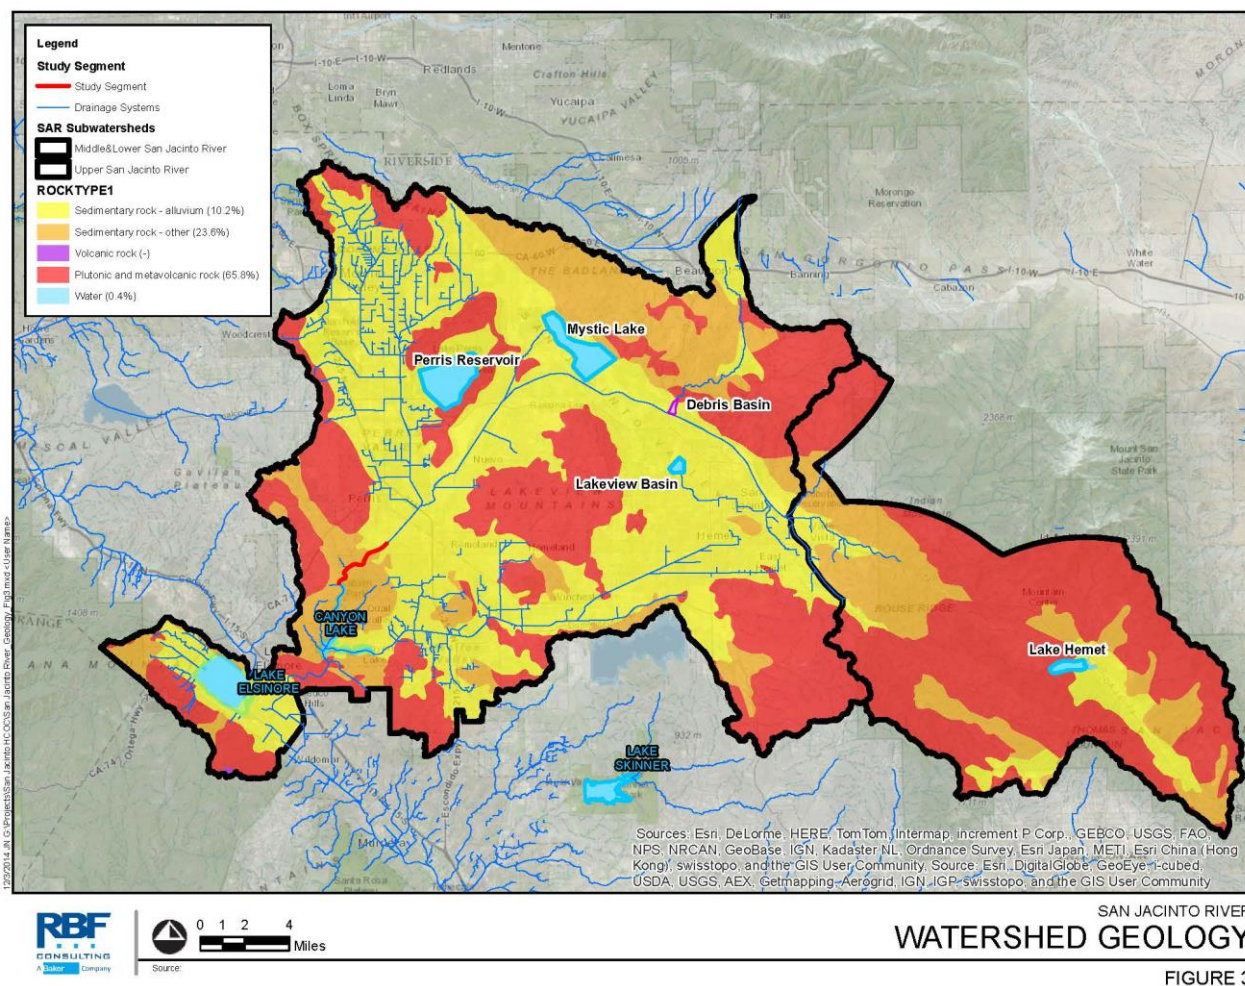
Figure 3 - San Jacinto River Watershed Geology Types

The soils present within the middle and lower San Jacinto River valley consist primarily of sedimentary rocks (67.6%). Sedimentary rocks notably account for 50.7% of alluvium and have the highest relative potential for erosion. Plutonic and metavolcanic rocks account for 32.4% of soil types within the middle and lower subwatershed, notably on the Santa Rosa Hills and the Lakeview Mountains that are in proximity to the San Jacinto River. The soil types in the San Jacinto River watershed are illustrated in Figure 3.

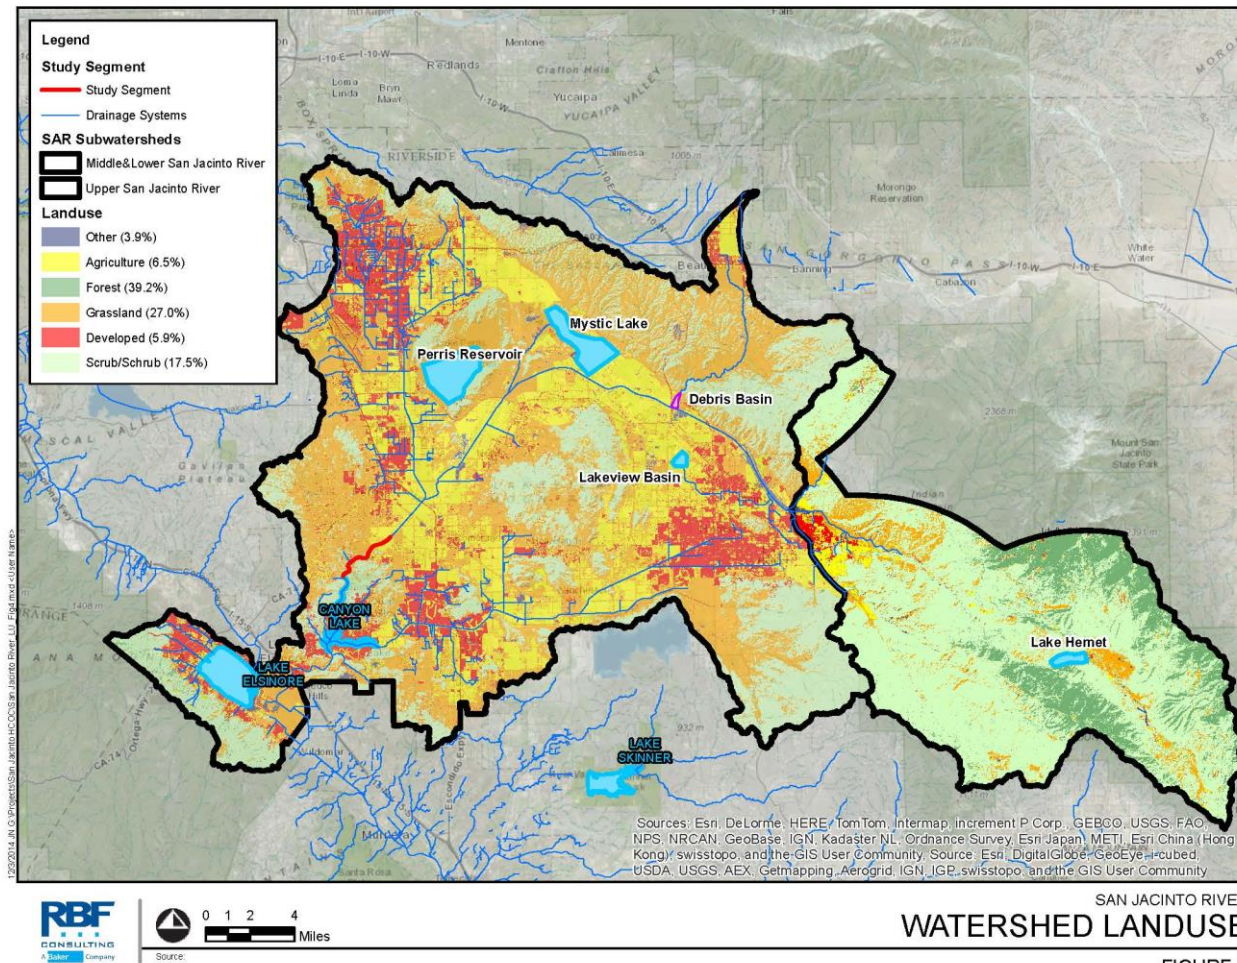
Figure 4 - San Jacinto River Watershed Land use Types

The Upper San Jacinto Subwatershed is for the most part undeveloped. Valle Vista, along with pockets of development in the upper reaches of the subwatershed, account for 5.9% of the entire drainage area located within Riverside County. Undeveloped areas include forest (39.2%), scrub/shrub (17.5%), grassland (27.0%), and agriculture (6.5%). The low levels of development have contributed to the maintenance of the natural hydrologic response of the subwatershed. The land use types in the San Jacinto River watershed are illustrated in Figure 4.

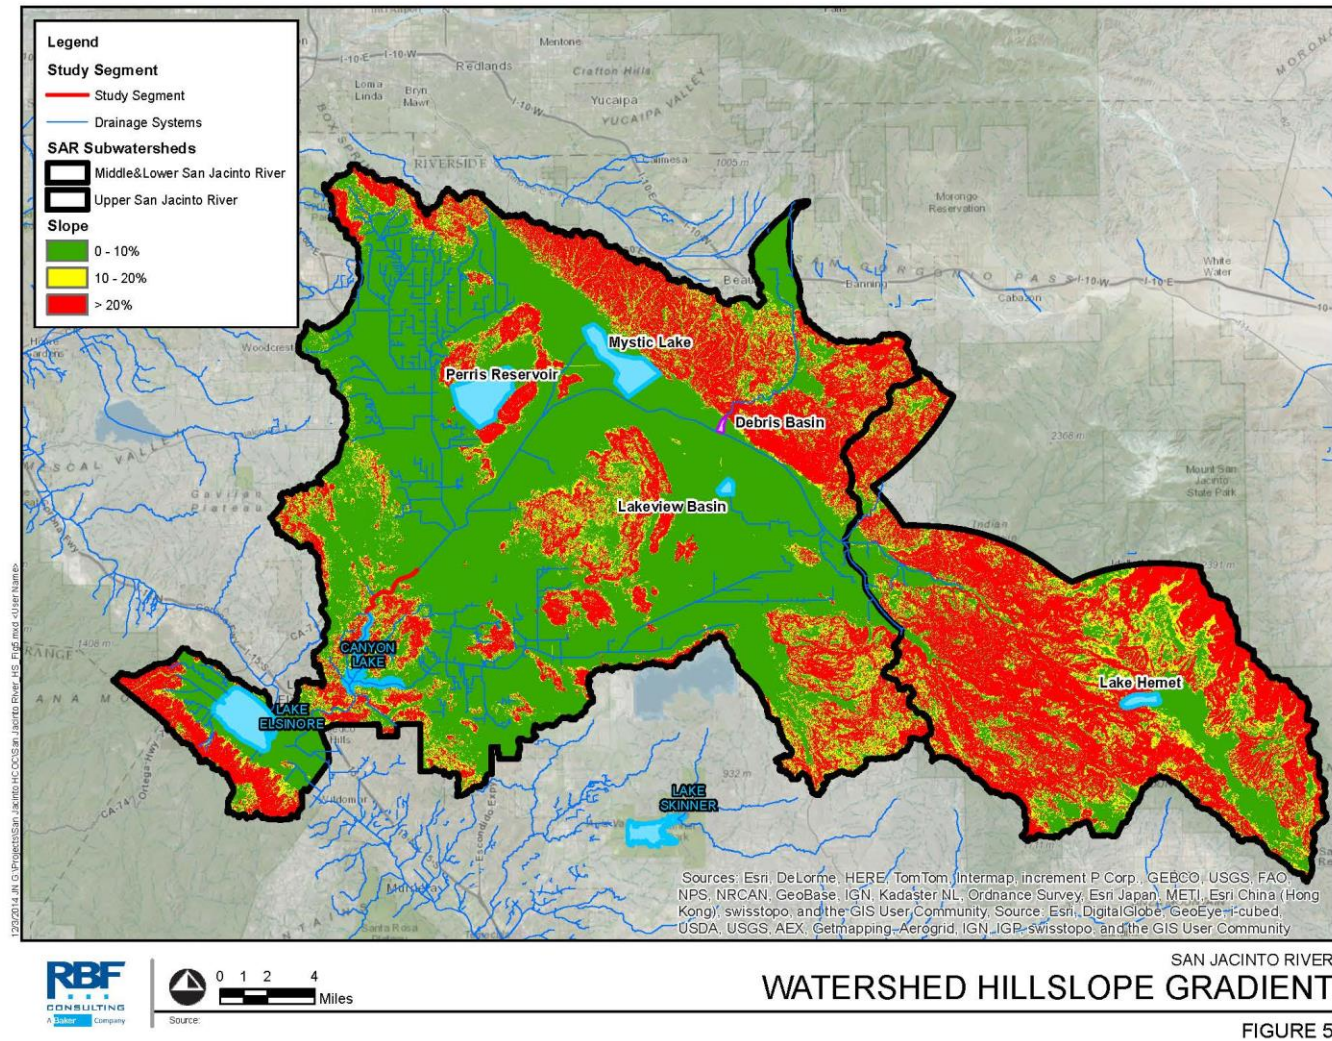
Figure 5 - San Jacinto River Watershed Hillslope Gradients

The subwatershed areas with a hillslope gradient greater than 21% provide the highest potential for erosion. These areas are concentrated on the upper reaches of the San Jacinto River near the San Jacinto Mountains, the Santa Rosa Hills, the Lakeview Mountains, and the Santa Ana Mountains surrounding Lake Elsinore. Majority of the middle and lower subwatershed has a hillslope gradient of 0-10% and has a lower potential for sediment production. While the majority of the developed land is located in the lower sediment production areas, the construction of the impoundments mentioned in section 1 have effectively obstructed a majority of the coarse sediment produced in high yield areas from reaching the downstream watercourse. The hillslope gradients for the San Jacinto River watershed are illustrated in Figure 5.

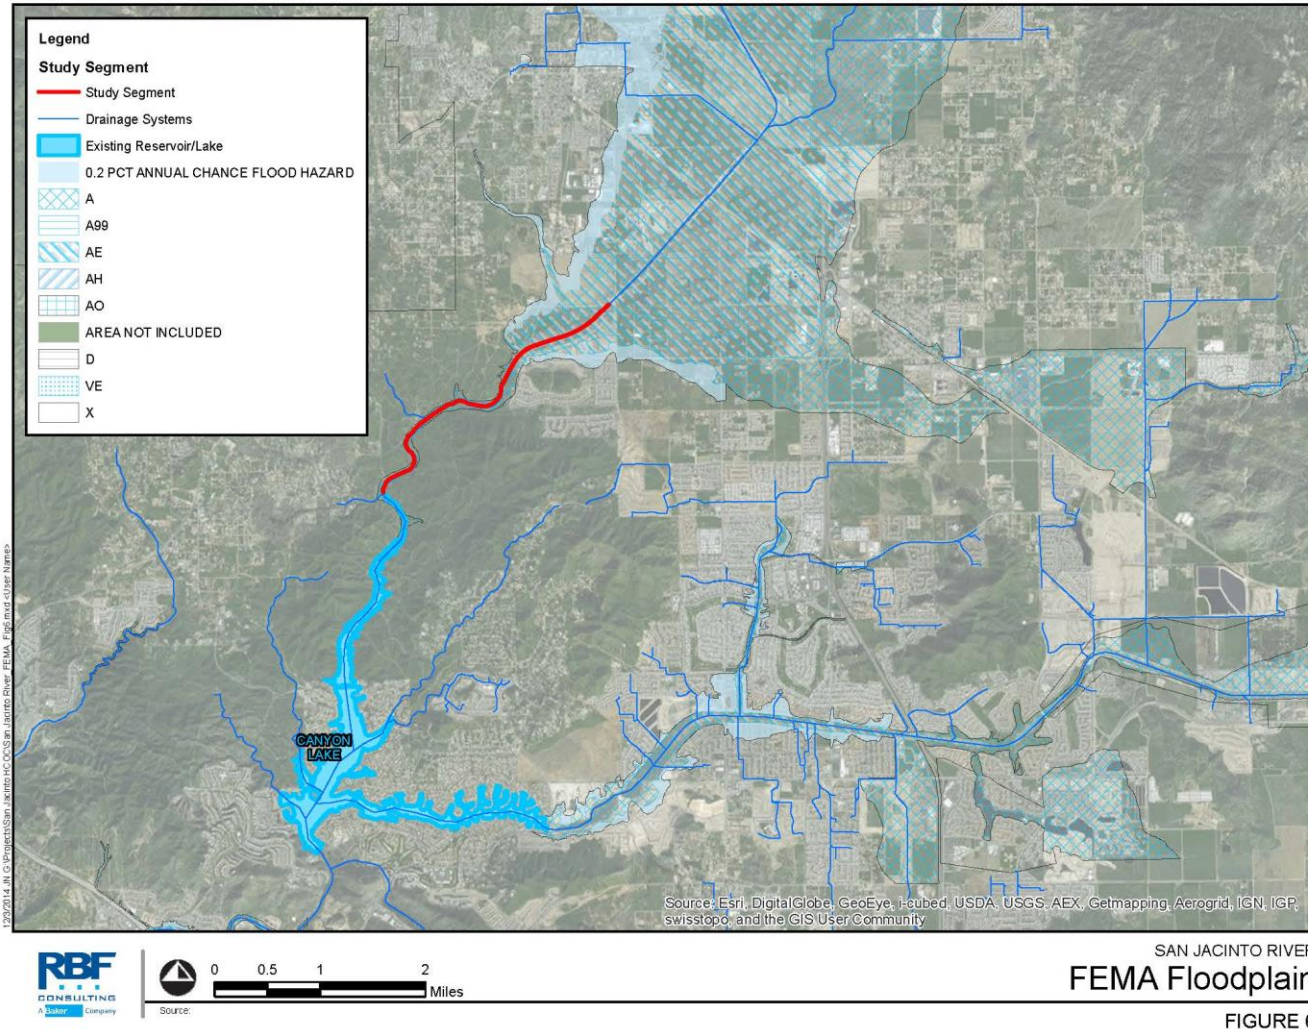
Figure 6 - FEMA Floodplain (FIRM 06065C2032G, 06065C2055H)

A review of the FEMA Flood Insurance Study (FIS), effective Flood Insurance Rate Maps (FIRMs) dated 08/18/2014 and historical FIRMs dated, 04/15/1980, 11/20/1996, and 08/28/2008 for the study segment indicate little to no change in the floodplain limits. Portions of the floodplain have been revised based on improvements that allow for new development along the study segment.

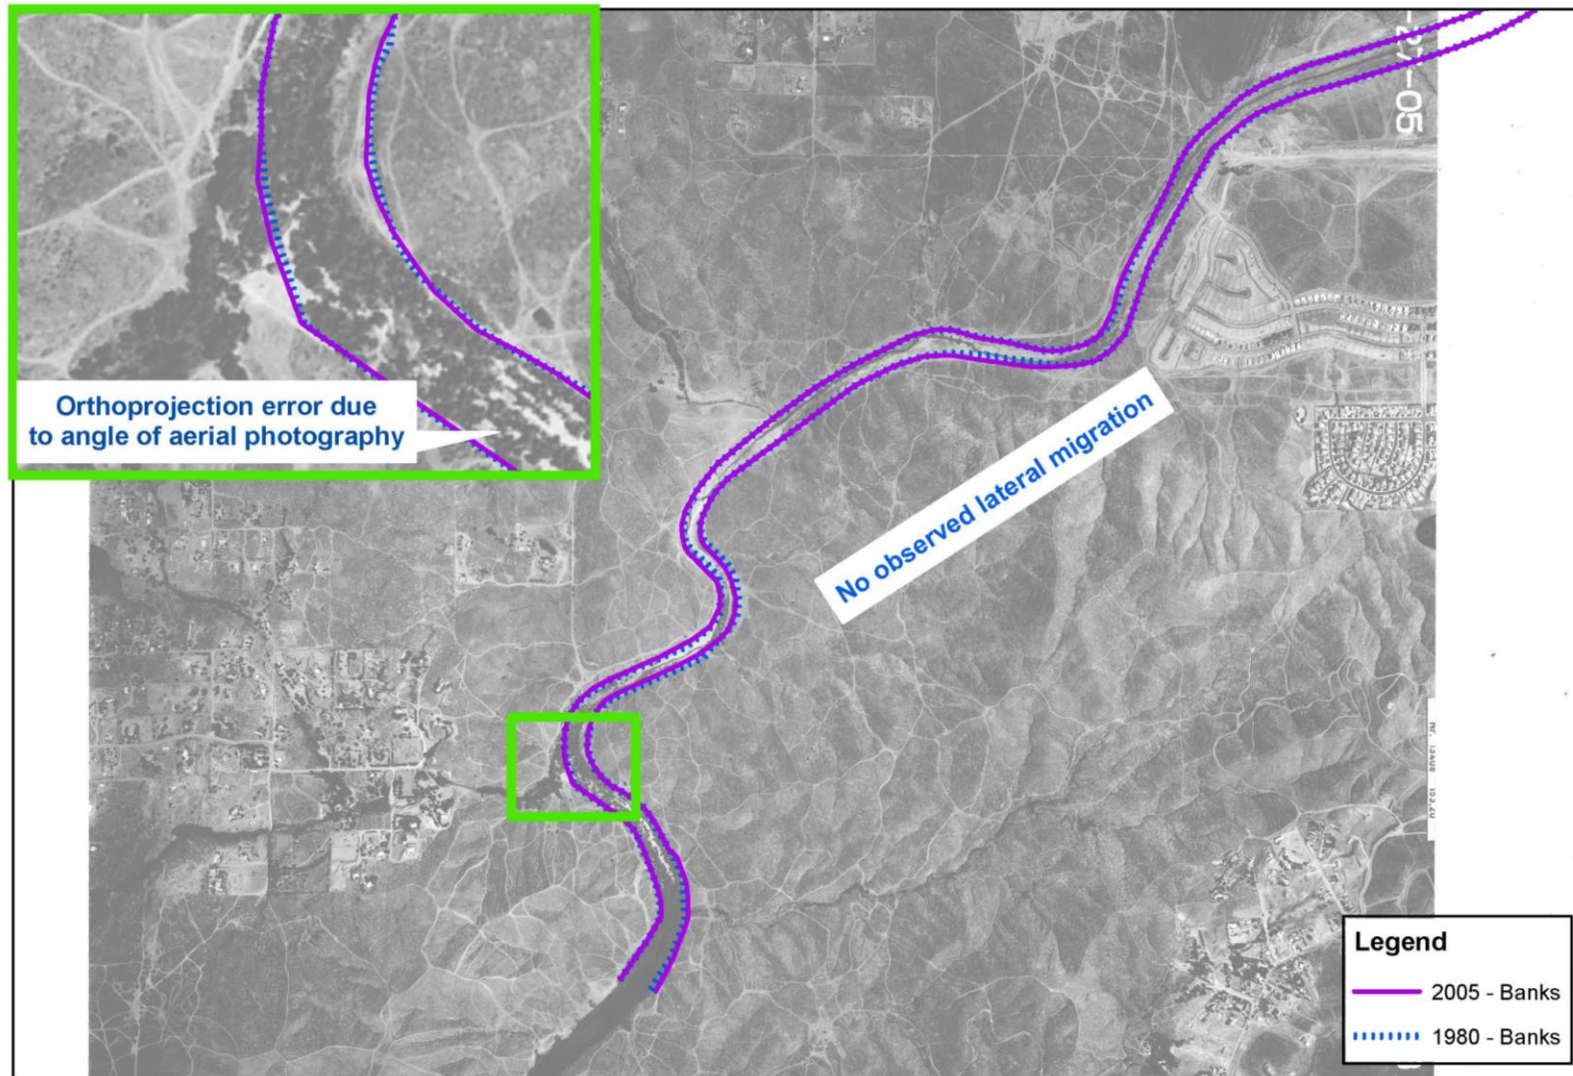
Figure 7 - Historical Streambank Comparison

A qualitative overview of historical movement and trends was conducted using a sequence of historical aerial photographs (1962-2010), focusing on the planimetric form and relative width as well as the encroachment of urban development and agricultural operations. The results of this historical assessment identified the channel shape as remaining consistent, with no lateral migration being observed.

Historical aerial photographs also show no noticeable erosion on the bed and banks of the channel. In addition, the vegetation within the streambed has remained dense and consistent over time along the study reach. Historical aerial photographs are included in Appendix A.

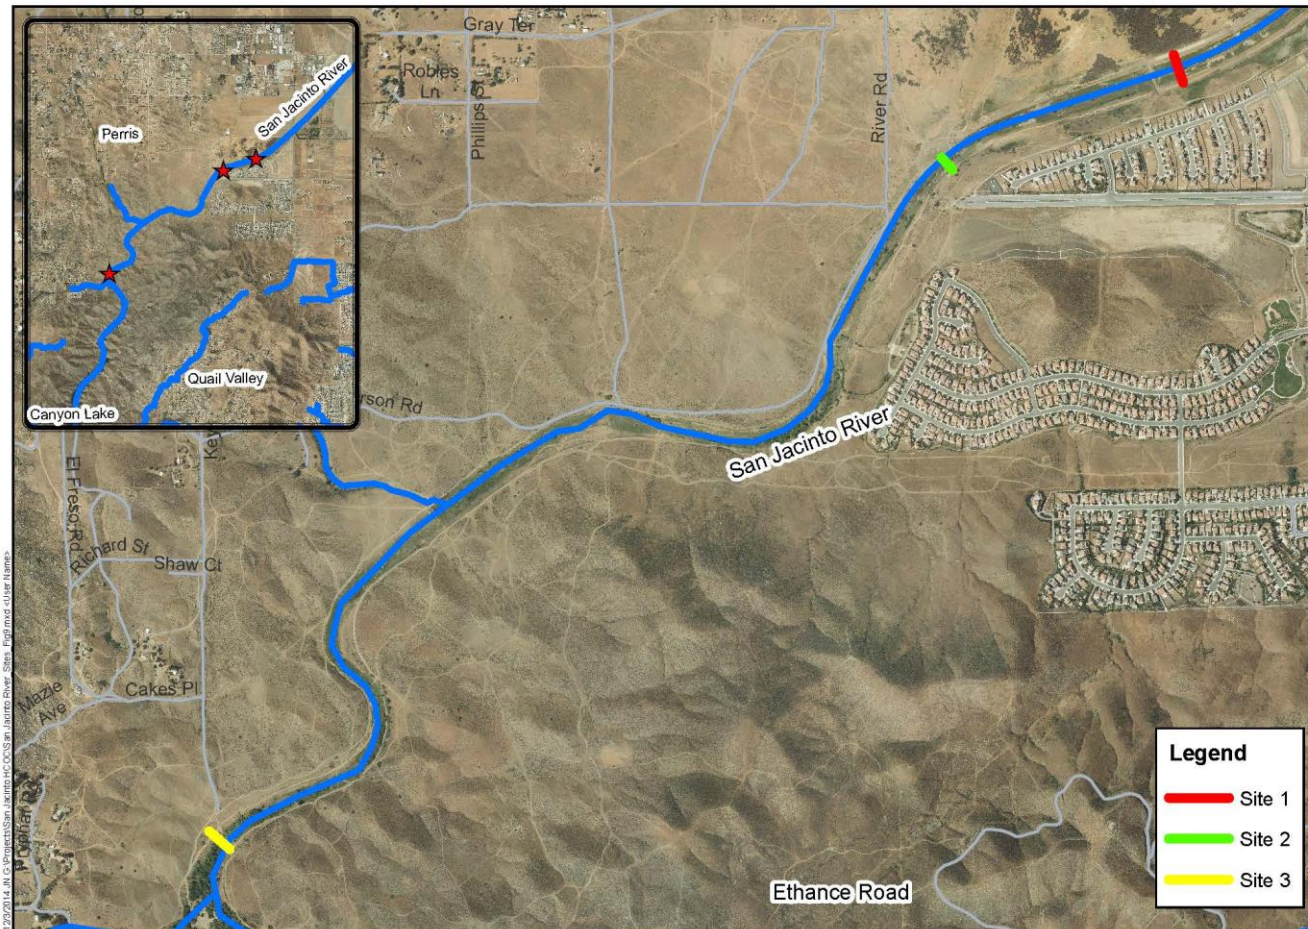
Figure 9 – Field Assessment Locations

The three field assessment sites were selected as they are representative of the conditions found along the 3.8-mile stream segment. Below is a description of the field observations made at each of the field assessment sites.

Figure 9 shows the location of the field assessments.

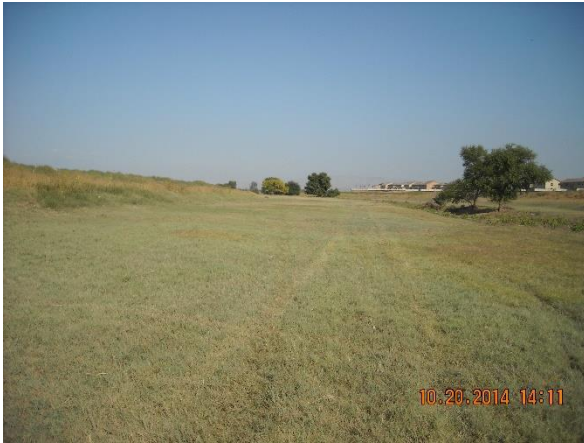
Site 1: The channel at this field assessment site shows no signs of headcutting or channel incision. The channel is fairly vegetated with grass, and trees have grown within the low-flow channel. This location is 3,000 feet downstream of Goetz Road. There is a dip crossing roadway 200 feet downstream of this location. These features act as a hard point and resist erosive forces which help with channel stabilization. The channel width is approximately 200-ft with a bank height of approximately 20-ft. The site location is along an engineered earthen section/levee. The low-flow channel at this location has a capacity of approximately 150 cfs.

Vegetation on the channel banks

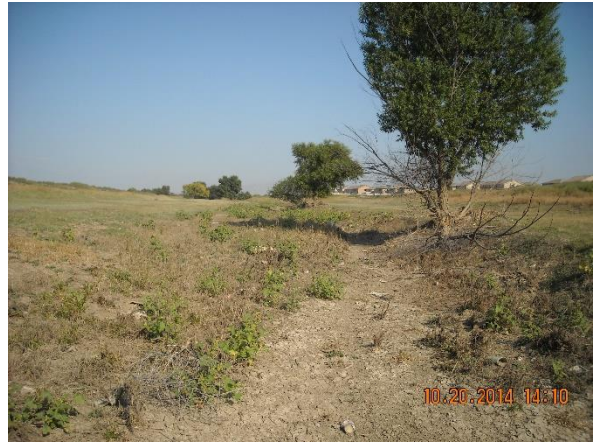
Low Flow channel – Looking upstream

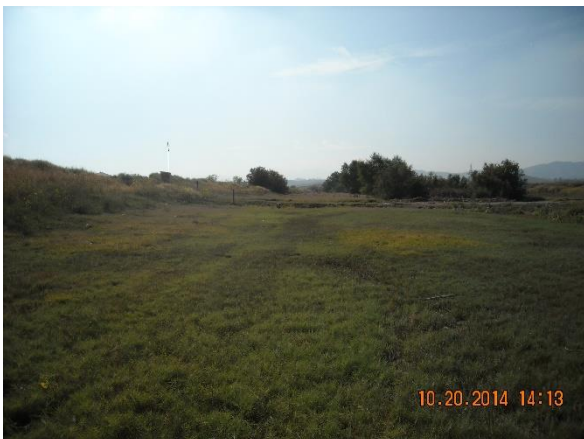
Looking downstream at dip crossing

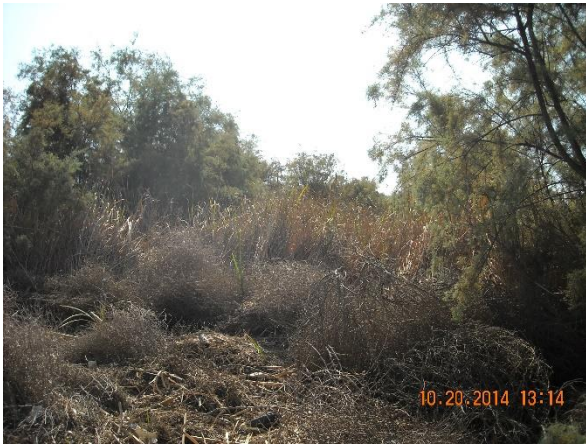
Site 2: This field assessment site is located within the segment of improved channel. There is no active erosion or headcuts visible, the channel is moderately vegetated and the toe of the natural channel bank is in good condition. There is a dip crossing roadway 2,500-foot upstream of this site location. This feature could act as a grade control by reducing the stream slope and flow velocity. The channel bottom width is approximately 130-ft with a height of approximately 25-ft. The low-flow channel is approximately 15-ft wide by 5-ft high. The low-flow channel at this location has a capacity of approximately 340 cfs.

Low-flow channel looking upstream

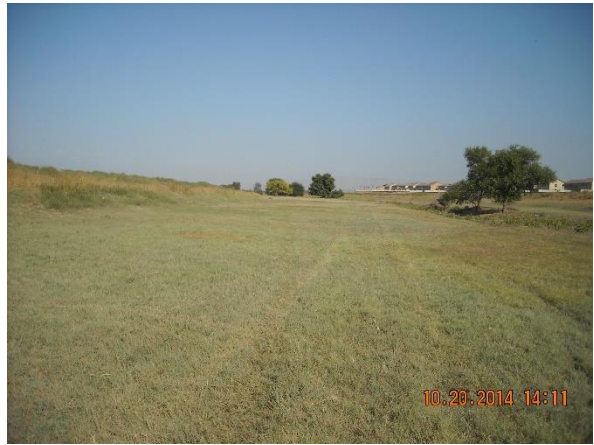
Moderately uniform vegetation.

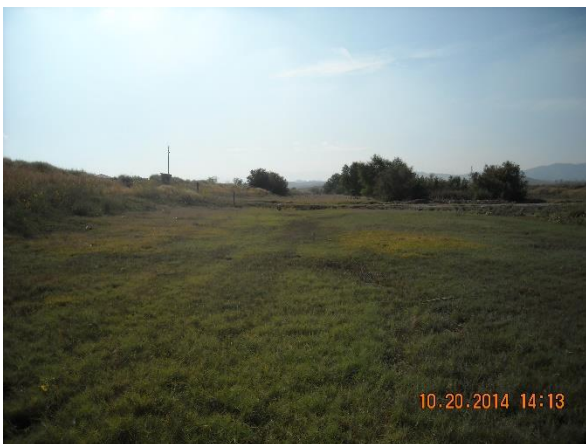
Channel bed

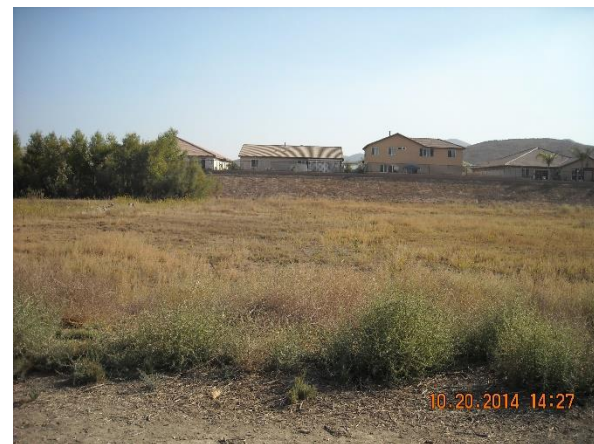
Channel Banks

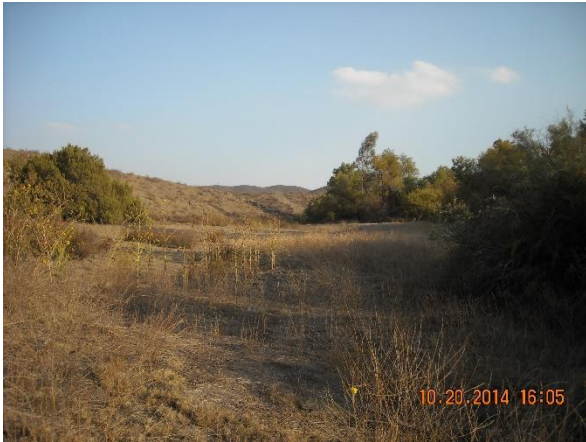
Site 3: This field assessment site contains some bedrock features along with dense vegetation. There are limited signs of toe erosion along the channel bank (less than 0.5'). The bed sediment is composed of coarser sediment ($D_{50} = 6 \text{ mm}$), as determined by a pebble count analysis. The channel width is uniform at this location. Low-flow channels are braided and separated by tall trees and dense vegetation, although the dominant discharge will submerge the entire bed uniformly. The low-flow channel at this location has a capacity of approximately 870 cfs.

Left bank looking upstream – wide floodplain

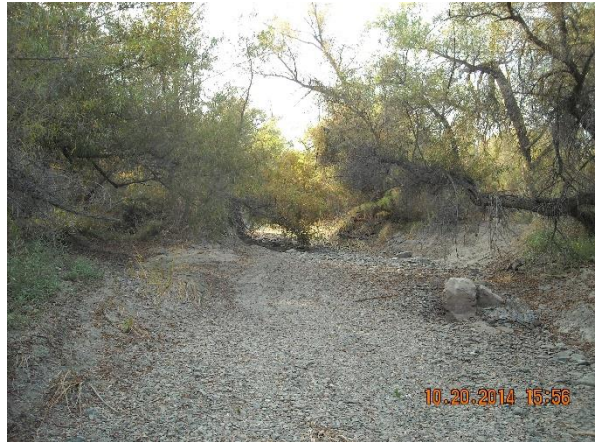
Coarse material along low-flow channel invert

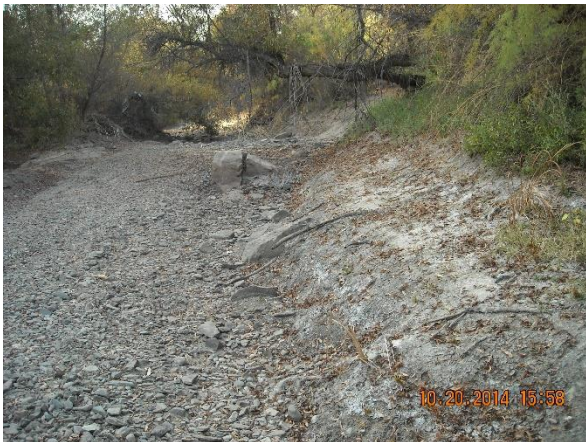
Coarse material along low-flow channel invert

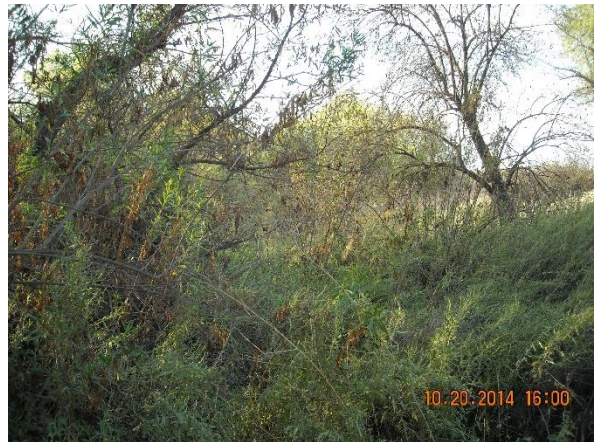
Dense vegetation along channel
