**Hydromodification Susceptibility
Documentation Report and
Mapping: Santa Ana Region**

January 18, 2017

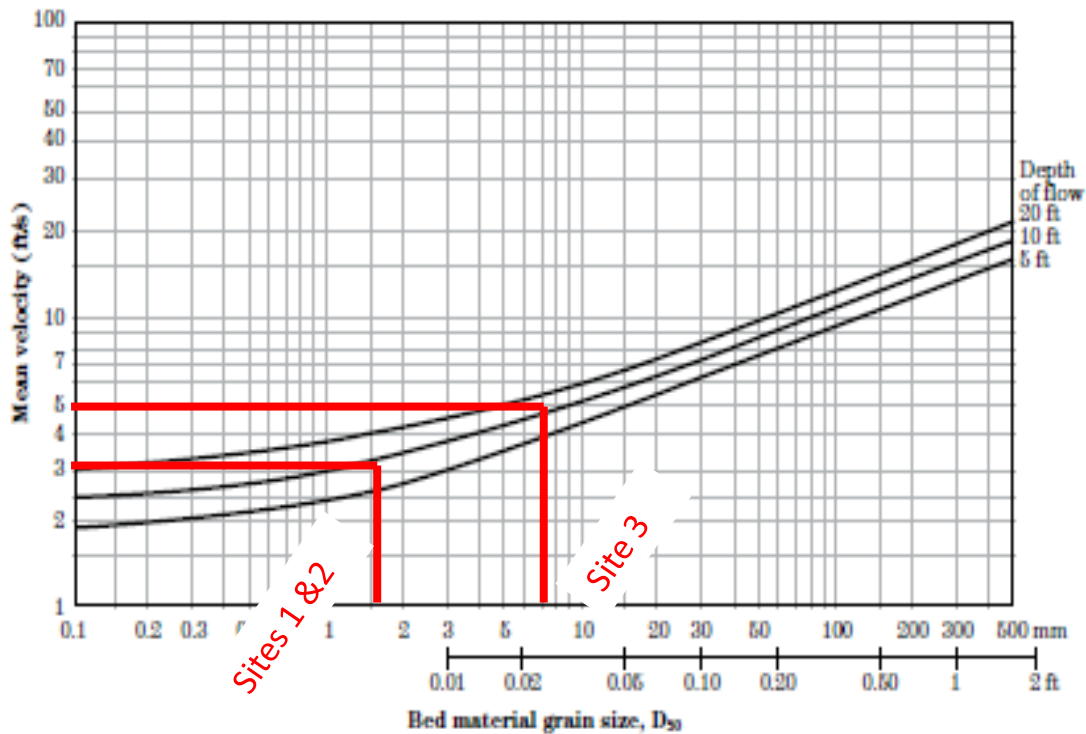
Figure 10 - Allowable velocity-depth grain chart (USACE, 1991)

Figure 8-3 Allowable velocity-depth grain chart

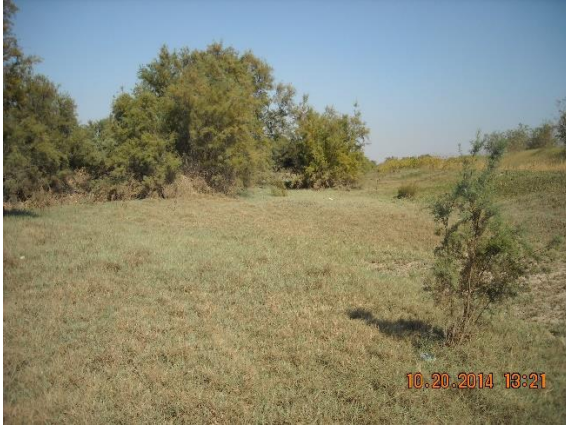
As part of the development of master-planned community adjacent to the East bank of the study segment, the channel was improved to provide a 100-year flood protection to the community. Channel improvements included the implementation of vegetation to stabilize soils and offer additional resiliency against potential scouring and the construction of a levee to protect the community.

Established vegetation on the channel bed

The established and maintained vegetation provides a higher allowable velocity without observing any scouring at field assessment Sites 1 and 2. USACE (1991b) provided allowable velocity criteria for nonscouring channel, which are consistent with the findings of the United States Department of Agriculture (USDA) Agricultural Handbook #667 (1987). At field assessment Sites 1 and 2, grass and vegetation provides an allowable velocity of 4 to 6 feet per second without scouring.

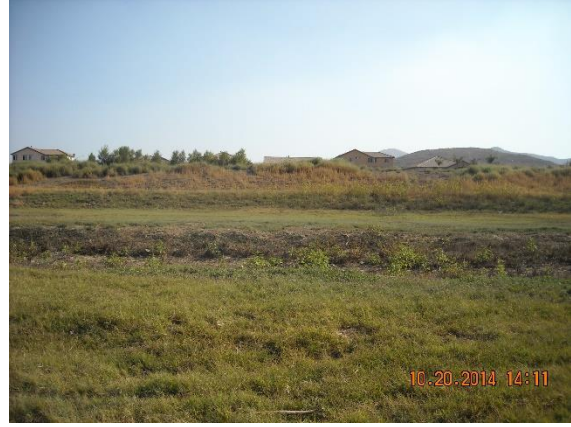
Left bank levee protecting the community
