Sediment Quantity and Nutrient Load Reduction Report

Prepared by Melissa Varela, Watershed Protection Division Riverside County Flood Control and Water Conservation District October 17, 2019

Sediment Quantity and Nutrient Load Reduction Report 2018-2019 Leach Canyon Dam and McVicker Canyon Basin Prepared by Melissa Varela, Watershed Protection Division Riverside County Flood Control and Water Conservation District October 17, 2019

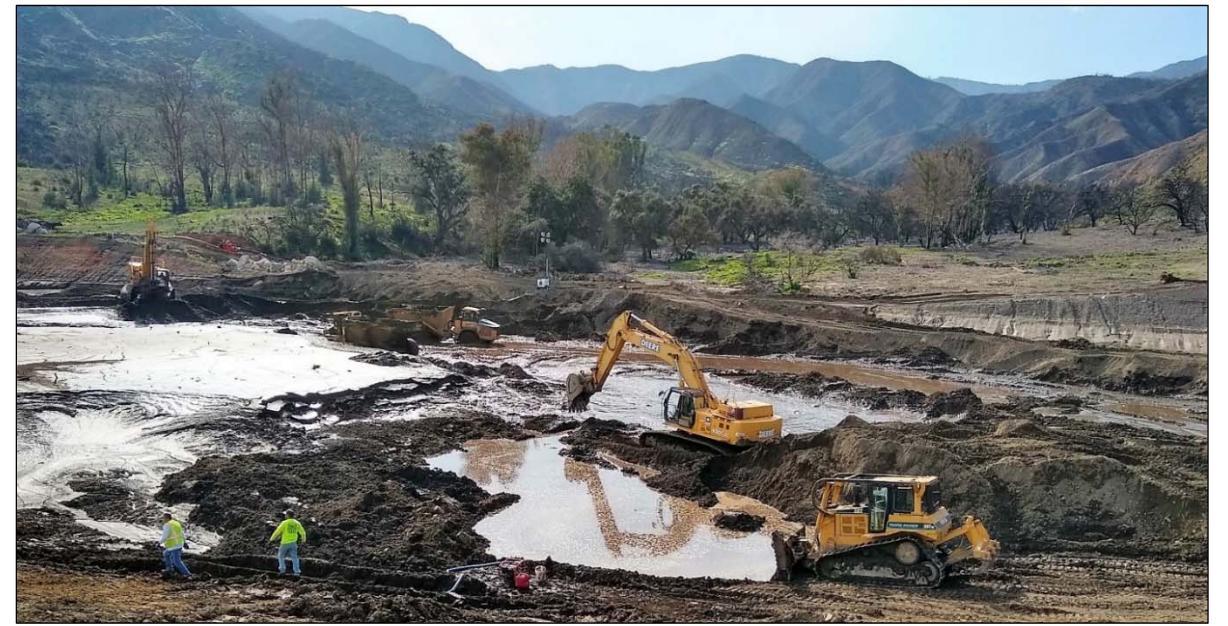
Figure 4 - Leach Canyon Dam (Upstream View) immediately after the 2/14/2019 storm event.

Following the February 14th, 2019 storm, excavations continued at Leach Canyon Dam in order to return the facility to the designed debris storage capacity. Upon arrival on March 1, 2019, District staff observed large excavators and front-loaders transferring post-fire debris flow material to several dump trucks for transport behind the west toe of the dam, refer to **Figure 4** and **Figure 5**. During the time of sampling, no flows were observed to be entering the basin from upstream. Due to maintenance crew activity at Leach Canyon Dam monitoring staff collected samples from the sediment stockpile drying area on the dam's east toe (refer to **Figure 2** and **Figure 6**). Appearance of the sediment showed variation of aggregate size, textures, organics (e.g., tree litter), consistency, and color.

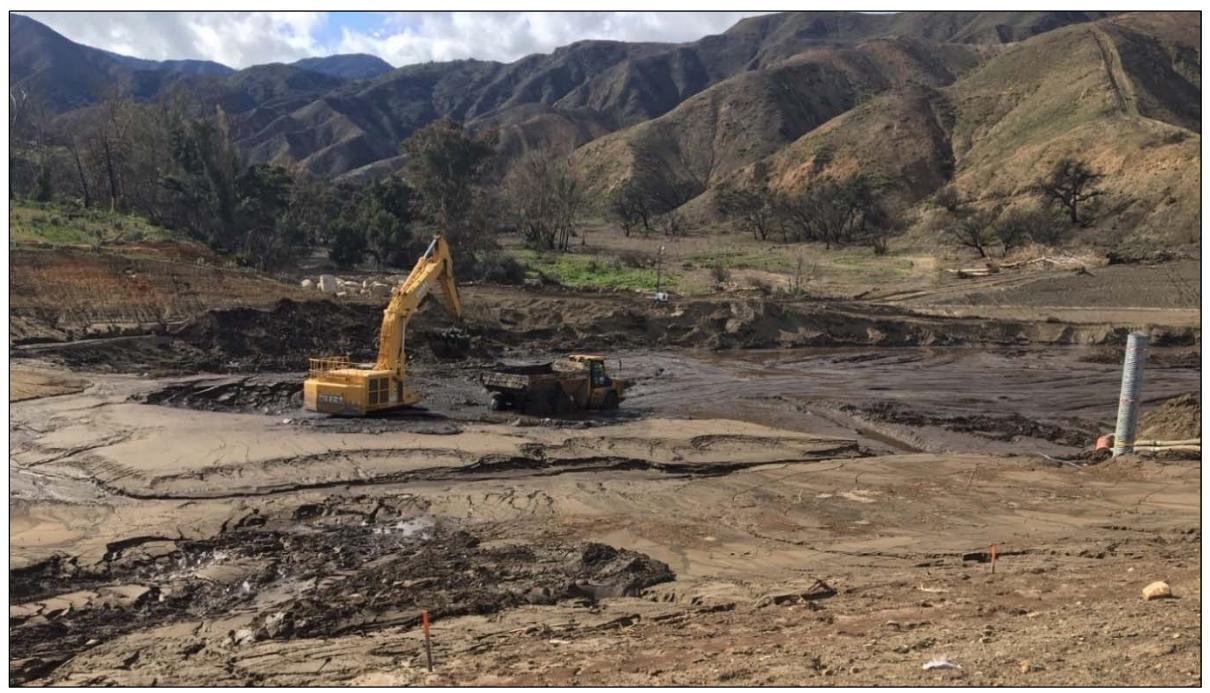
Figure 5 - Leach Canyon Dam (Upstream view) in March 2019.

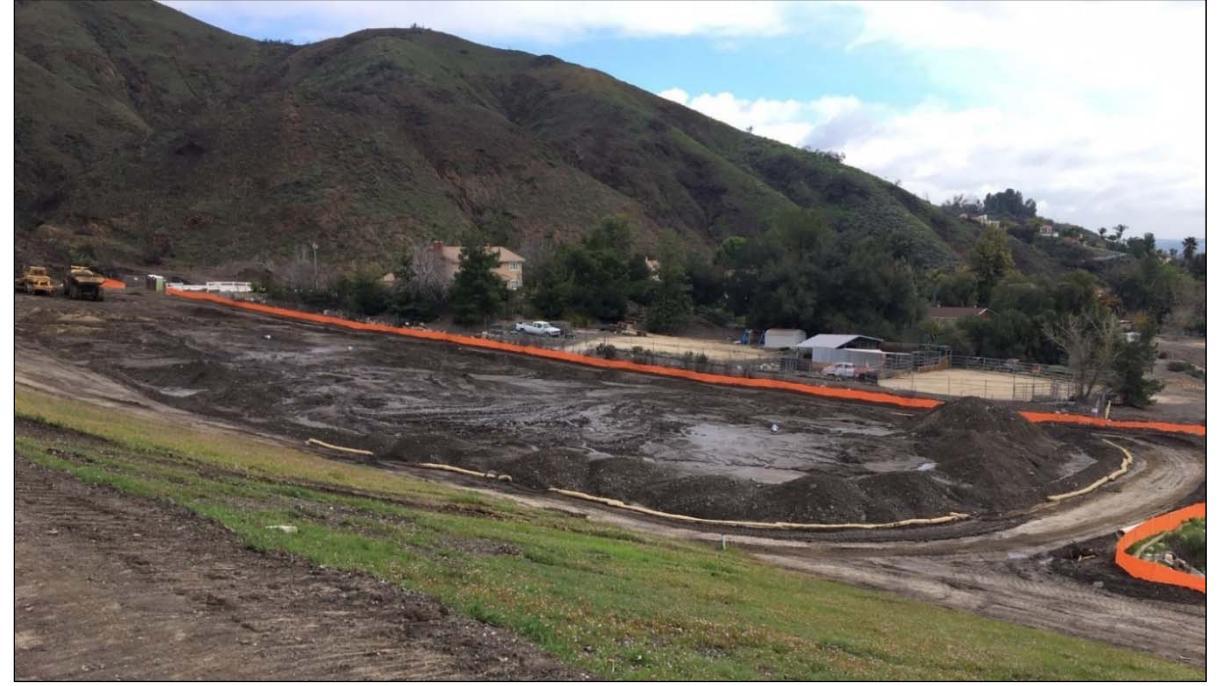
Figure 6 - Leach Canyon Dam (Downstream View) at stockpile staging area.

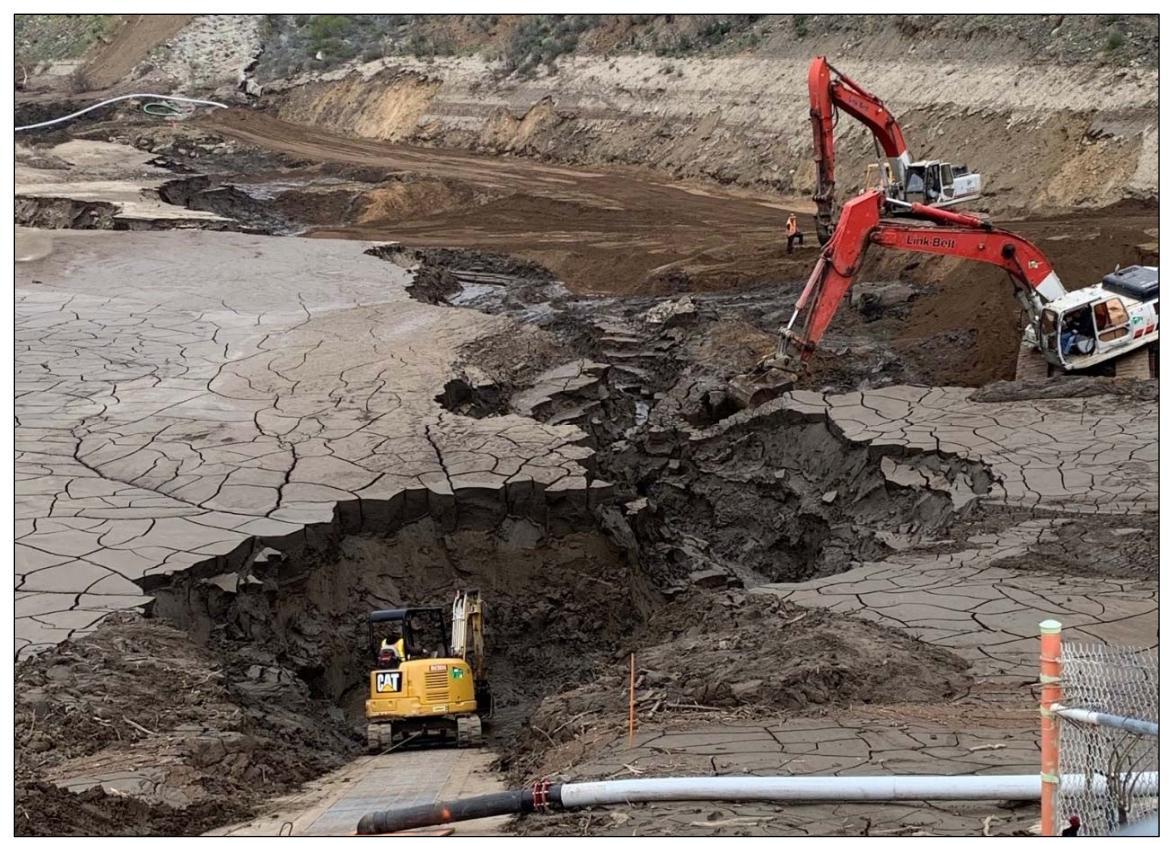
Figure 7 - McVicker Canyon Basin (Upstream View) excavation area.

Upon arrival on March 1, 2019, District staff observed significant amounts of sediment, boulders and vegetation in the McVicker Canyon Basin, which appeared to have been deposited in a short period of time likely due to the unique topographical characteristics and narrow canyons upstream of the McVicker Canyon Basin. Staff observed flowing residual stormwater as it moved through hillside rills and entered the project site (refer to **Figure 7**). At the time of sampling, District maintenance and operations (O&M) crews were actively clearing and transporting material from the basin (refer to **Figure 3**). Similar to Leach Canyon Dam, site conditions prompted monitoring staff to sample from the safely accessed sediment stockpile staging area (see **Figure 8**). The sediment collected was highly saturated with variations of aggregate type, textures, organics (e.g., tree litter), consistency, and color.

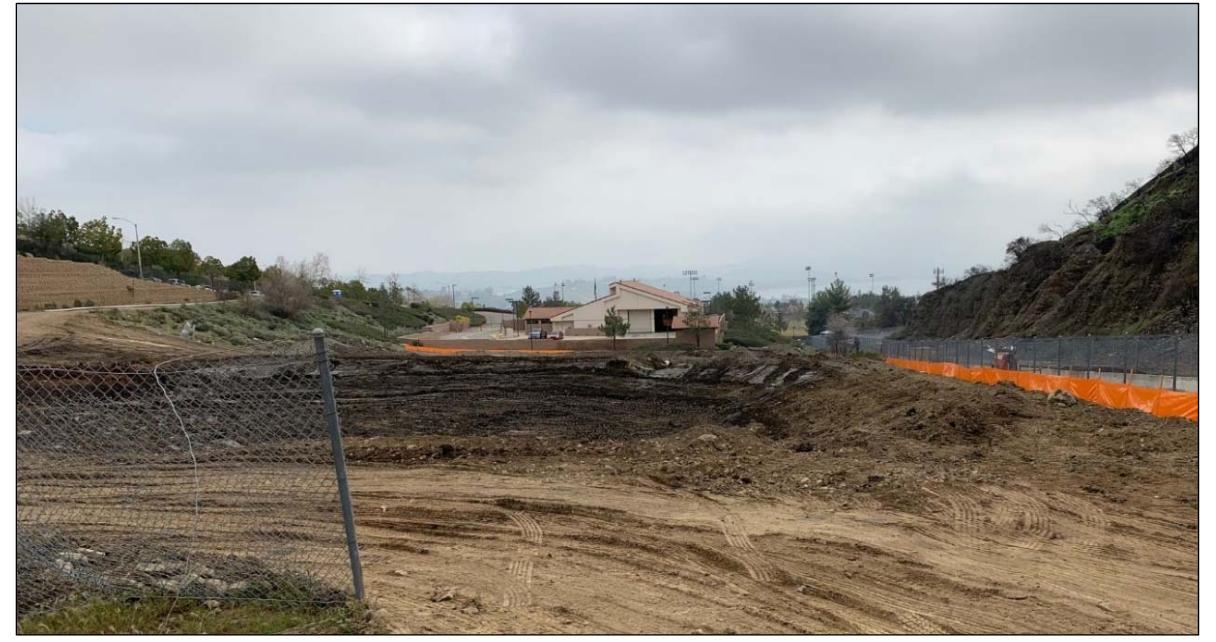
Figure 8 - McVicker Canyon Basin (Downstream View) at stockpile staging area.

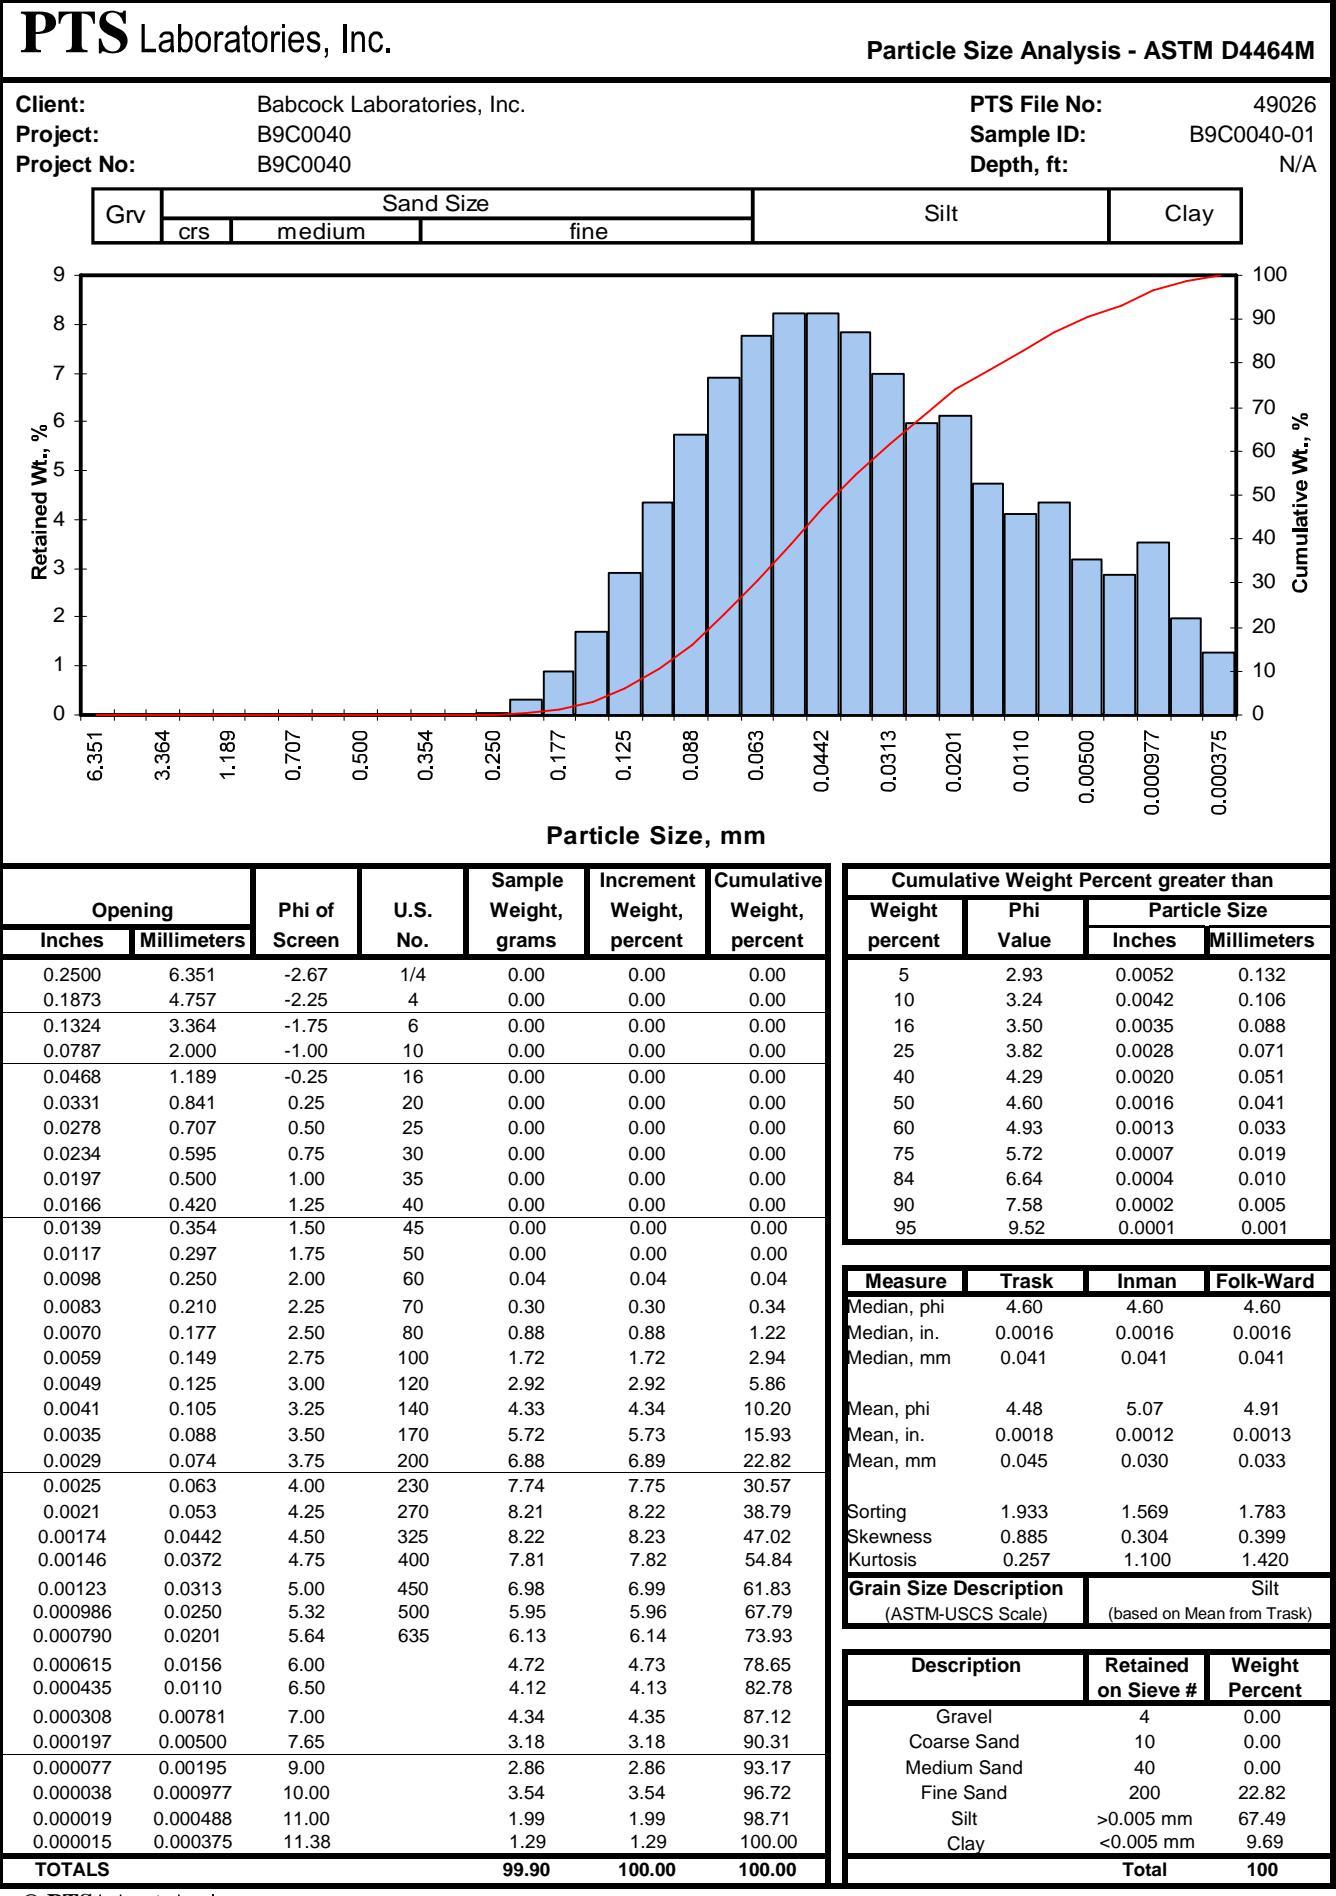
Median		Particle	Size Distrik	bution, wt.	percent		Silt
		Mean Grain Size	Grain Size			Sand Size				ళ
Sample ID	Depth, ft.	Description (1)	mm	Grave	Coarse	Medium	Fine	Silt	Clay	Clay
B9C0040-01	N/A	Silt	0.041	0.00	0.00	0.00	22.82	67.49	69.69	77.18

Tuble 1 Summary of Grum Size Furthere Fest									
Percent Composition (%) ¹									
Sample Course Medium Fine ASTM									
Location	Gravel	Sand	Sand	Sand	Silt	Clay	Classification		
LC3	0	0	0	22.82	67.49	9.69	Silt		
MV2	0	0	1.1	11.35	51.63	35.93	Silt

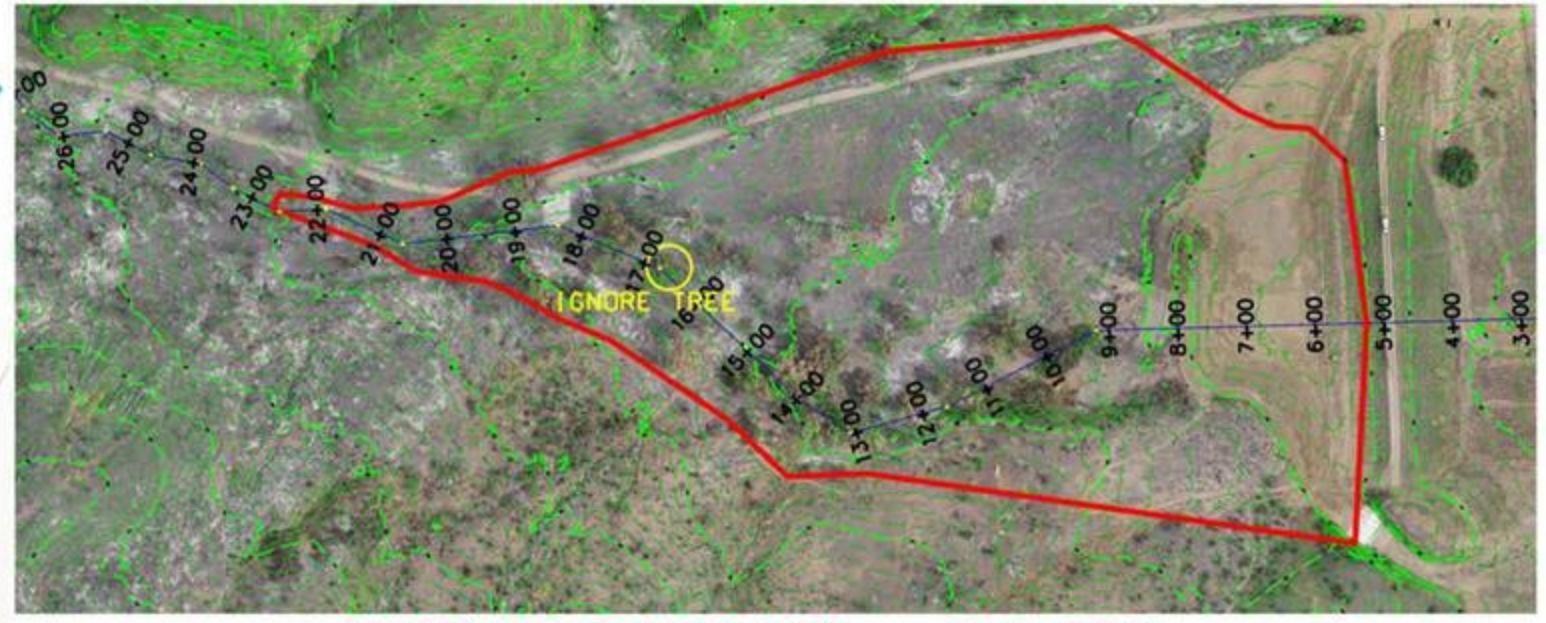
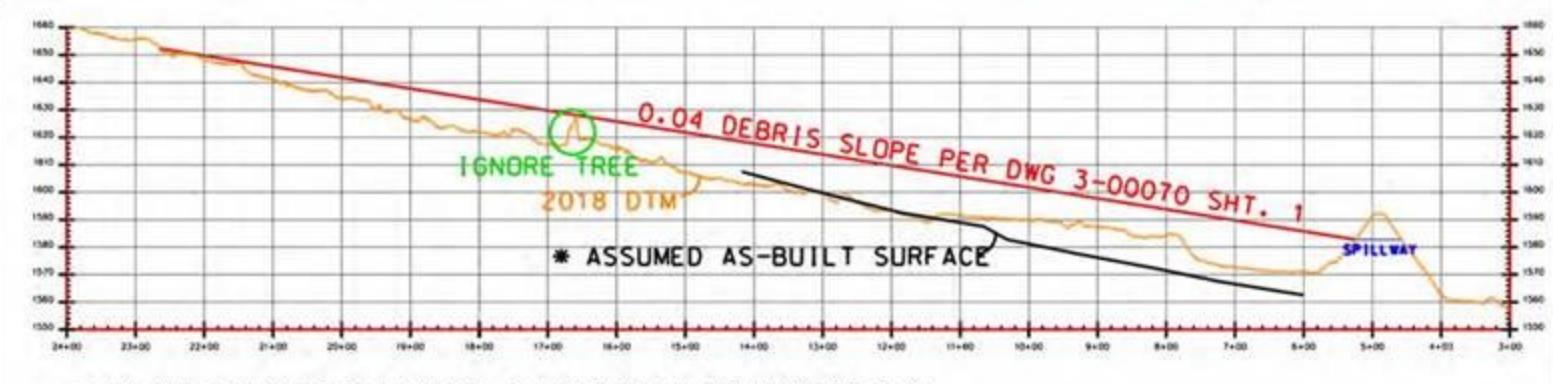
Leach Debris Capacity

d. Original DTM used from 8-29-2018 drone flight and was modified with grading changes to improve dam capacity (includes 2 feet of dead storage).

DEBRIS CAPACITY = 94,000 cuyds

AS-BUILT BACKUP IS LACKING. PLANS CONTAIN CONTENTIOUS DATA.

CY, however, according to the 2018 Post-Holy Fire Digital Terrain Model (DTM) debris capacity survey with 4% debris slope, Leach Canyon Dam has 141,974 CY of debris capacity, see **Attachment 6** and **Attachment 7**. Prior to dam capacity improvements, District maintenance crews removed 20,000 CY of wet sediment. As the storm season progressed and leading up to the February 14th, 2019 storm event, District maintenance crews removed 59,376 CY of wet sediment (approximately 46,325 CY of it had accumulated historically). An additional 20,048 CY of wet sediment was removed just after the February 14th storm. In total, from September 2018 through April 2019, District maintenance crews removed approximately 99,424 CY of wet sediment from Leach Canyon Dam, which is equivalent to 11,928 truckloads hauled.
